Deer Creek Erosion Control Project

FINAL REPORT

California State University, Chico Research Foundation

August, 2001

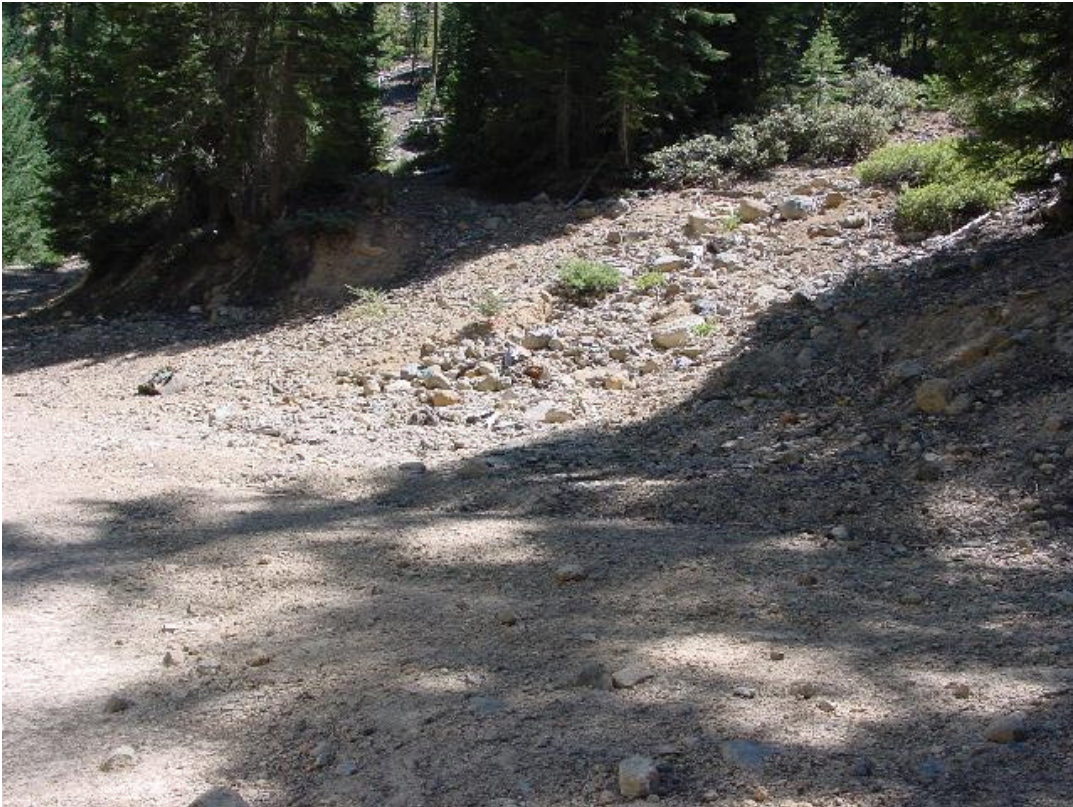
Photo 4.5b

Site 4.5—Above

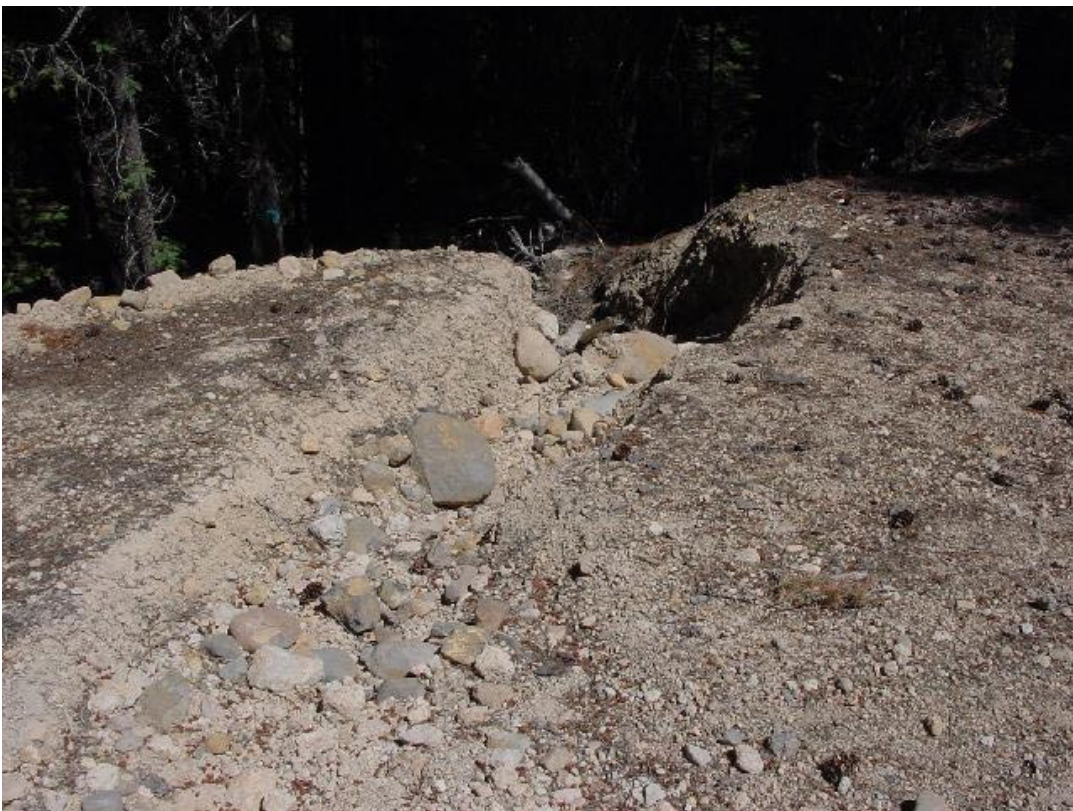
Photo 4.5c

Site 4.5—Below

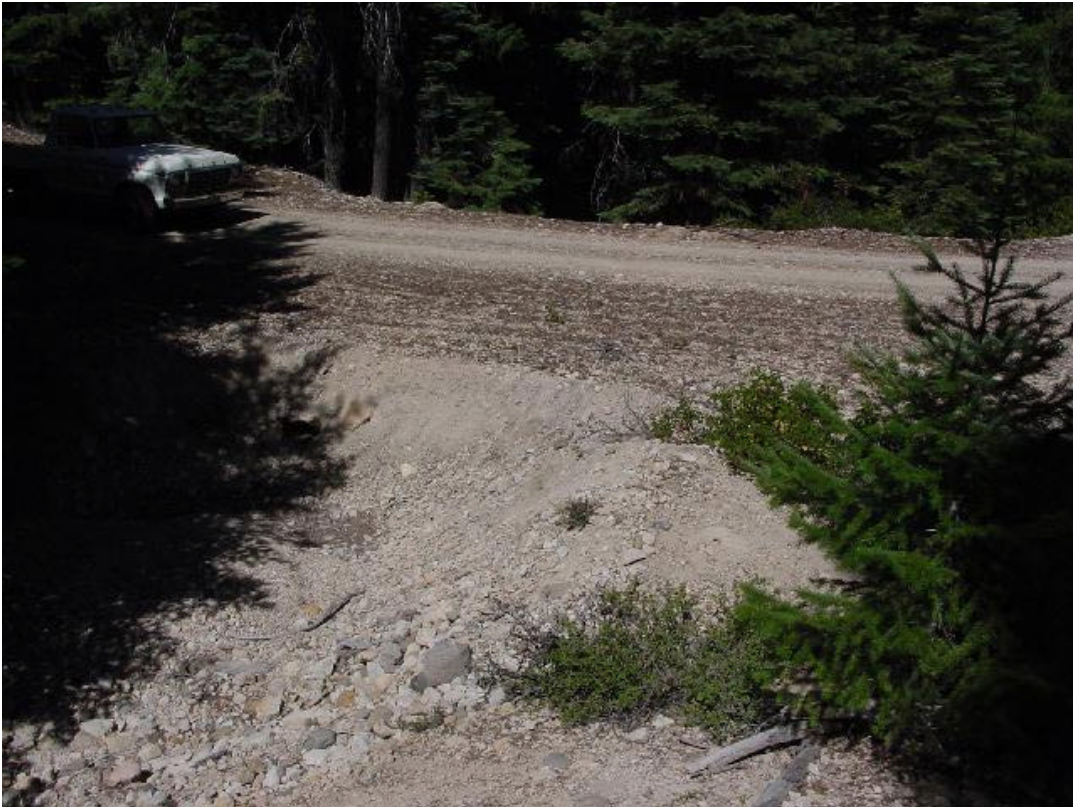
Photo 4.6a

Site 4.6—Above

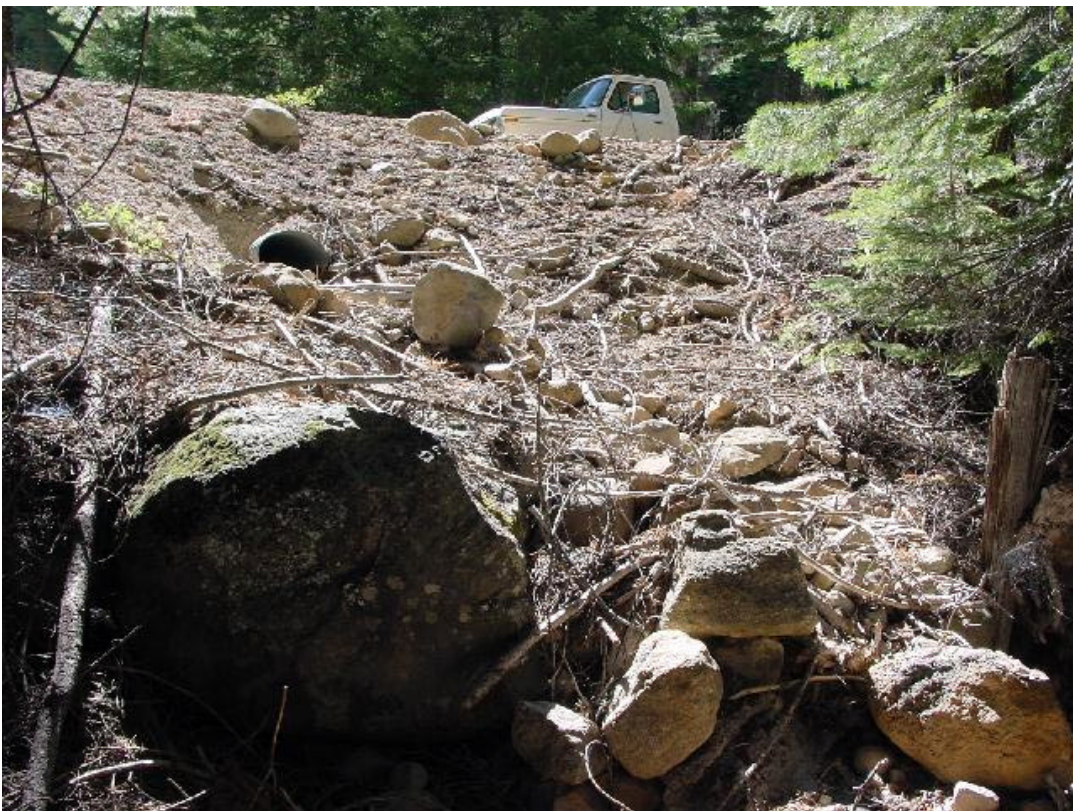
Photo 4.6b

Site 4.6—Below

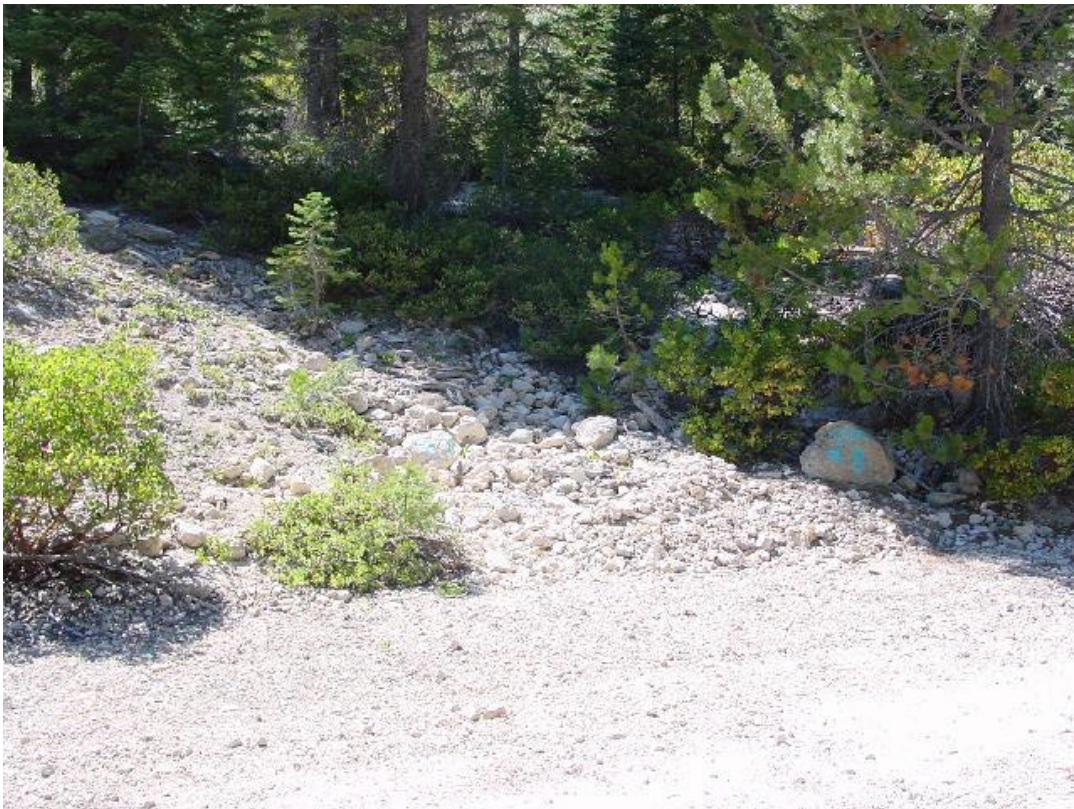
Photo 4.7a

Site 4.7—Above

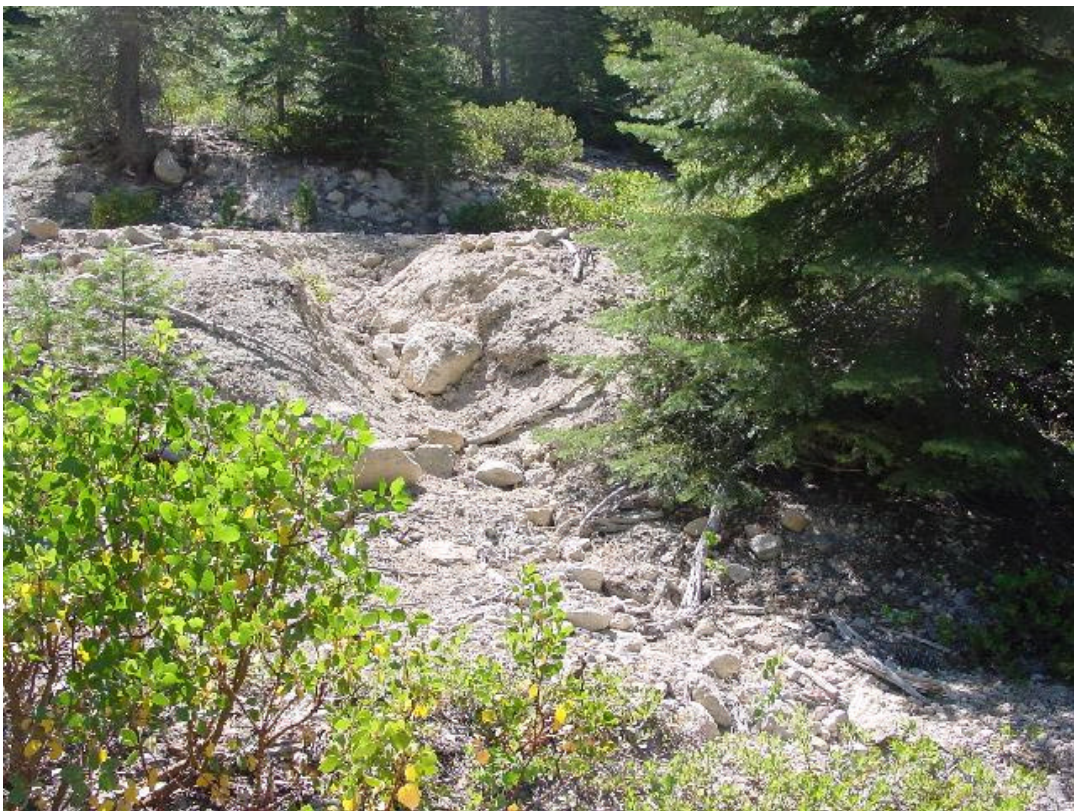
Photo 4.7b

Site 4.7—Below

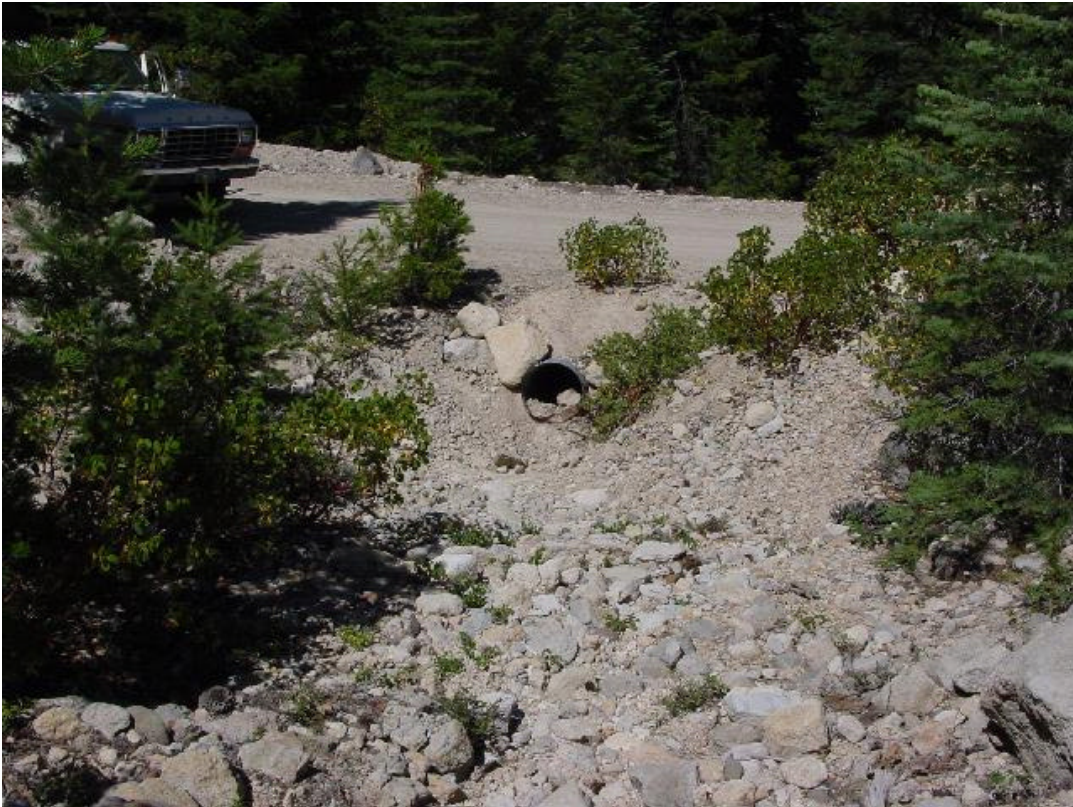
Photo 4.8a

Site 4.8—Above

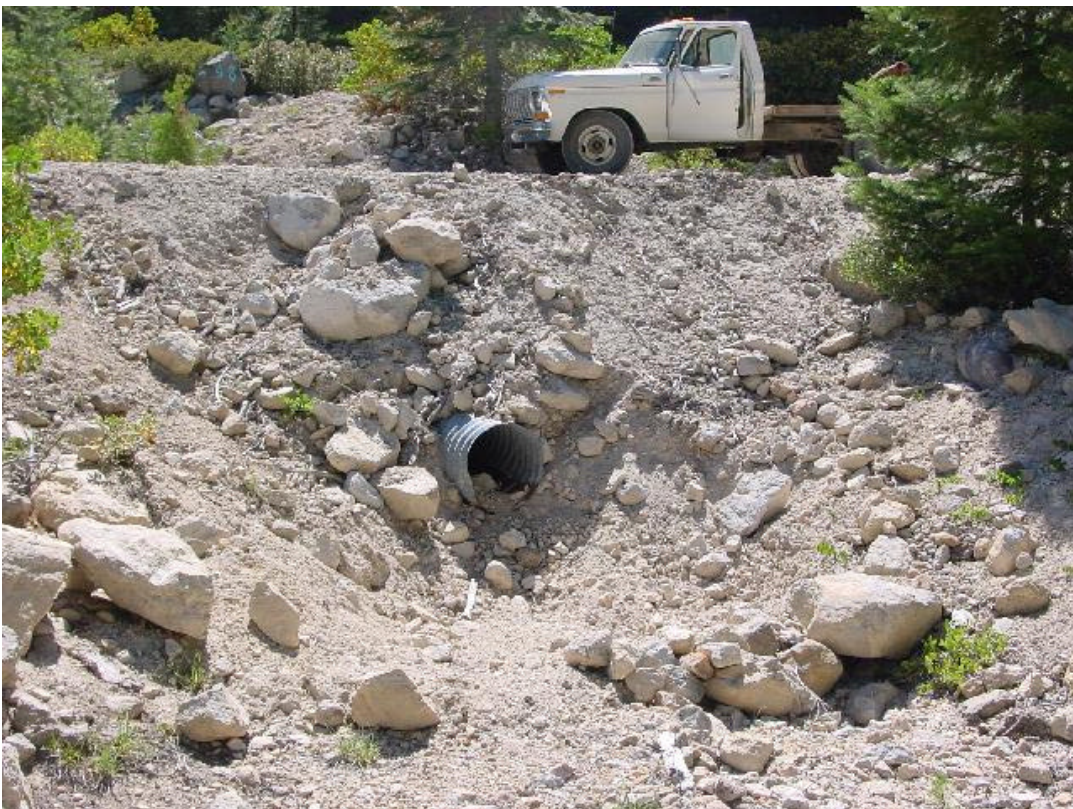
Photo 4.8b

Site 4.8—Below

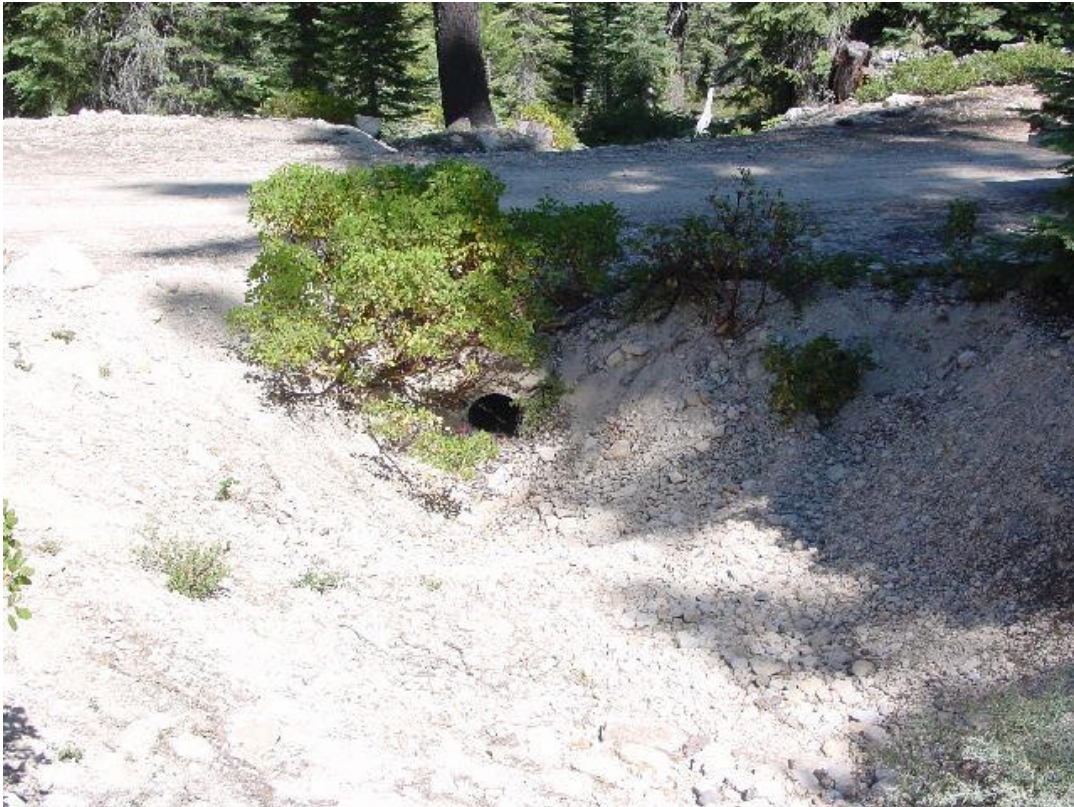
Photo 4.9a

Site 4.9—Above

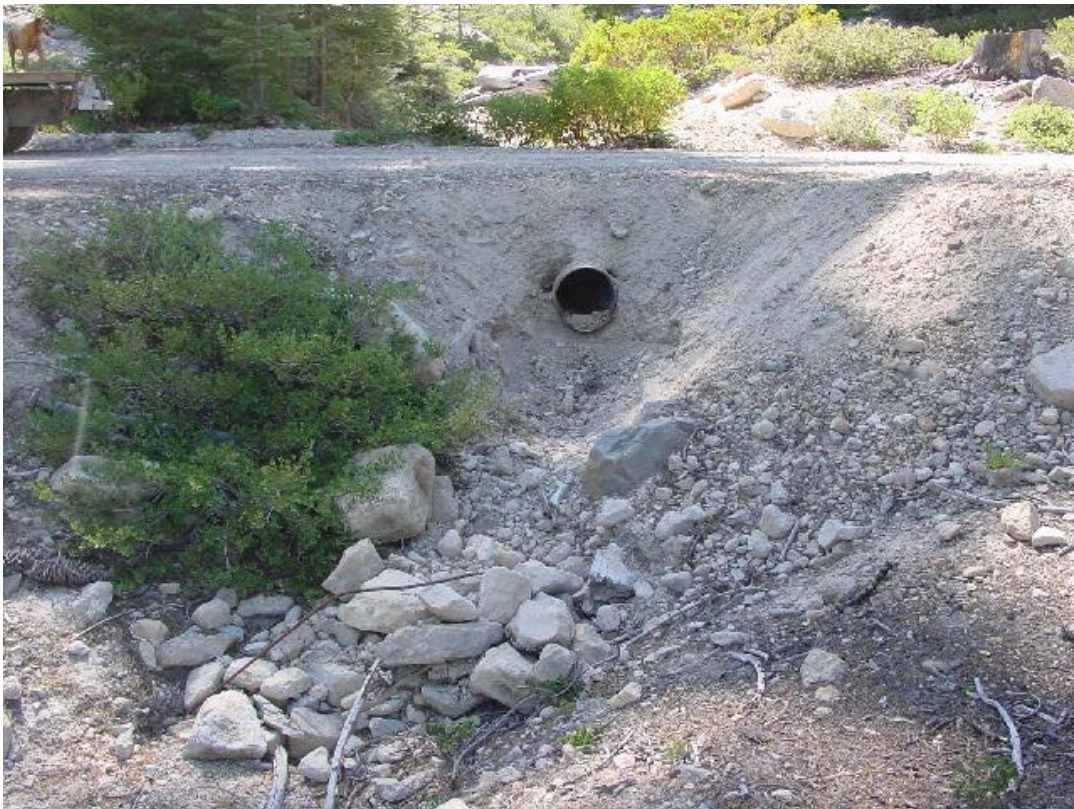
Photo 4.9b

Site 4.9—Below

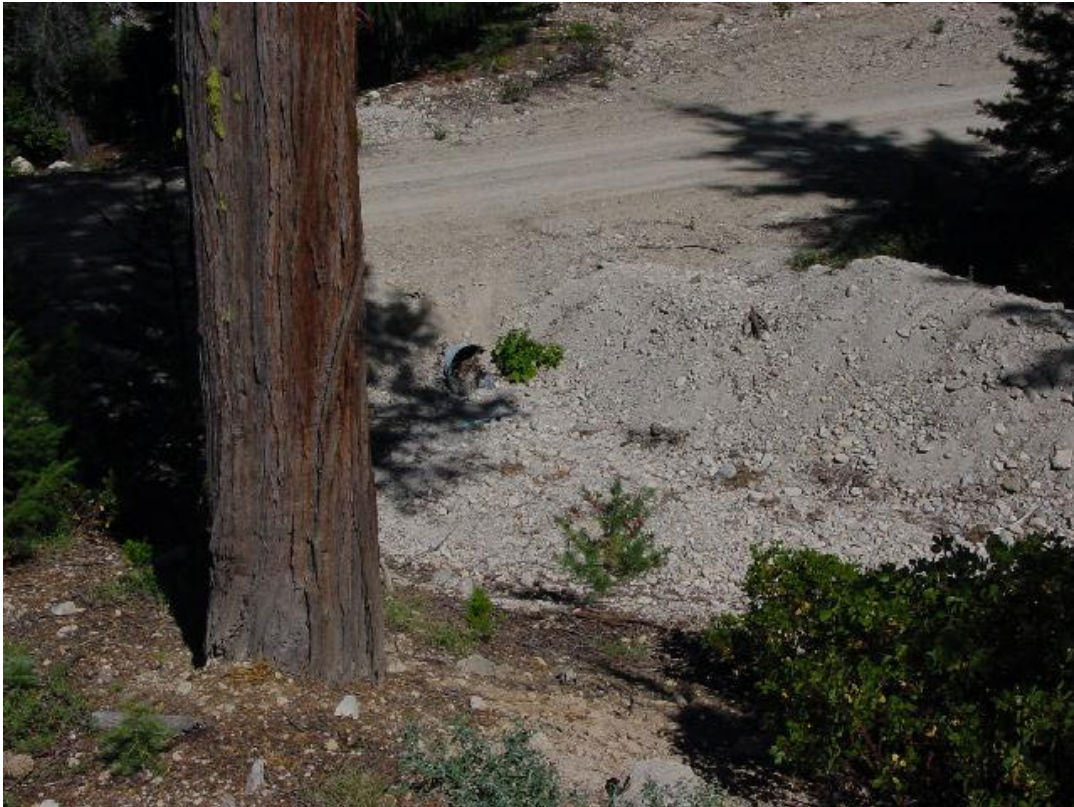
Photo 4.10a

Site 4.10—Above

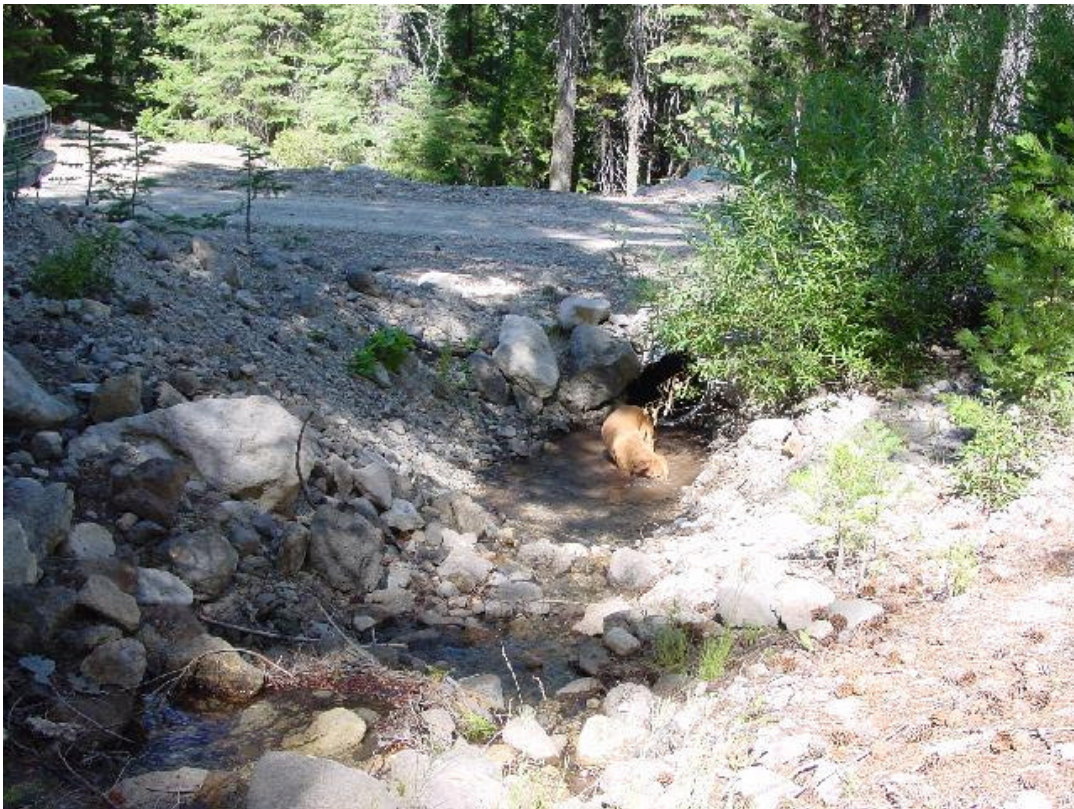
Photo 4.11a

Site 4.11—Above

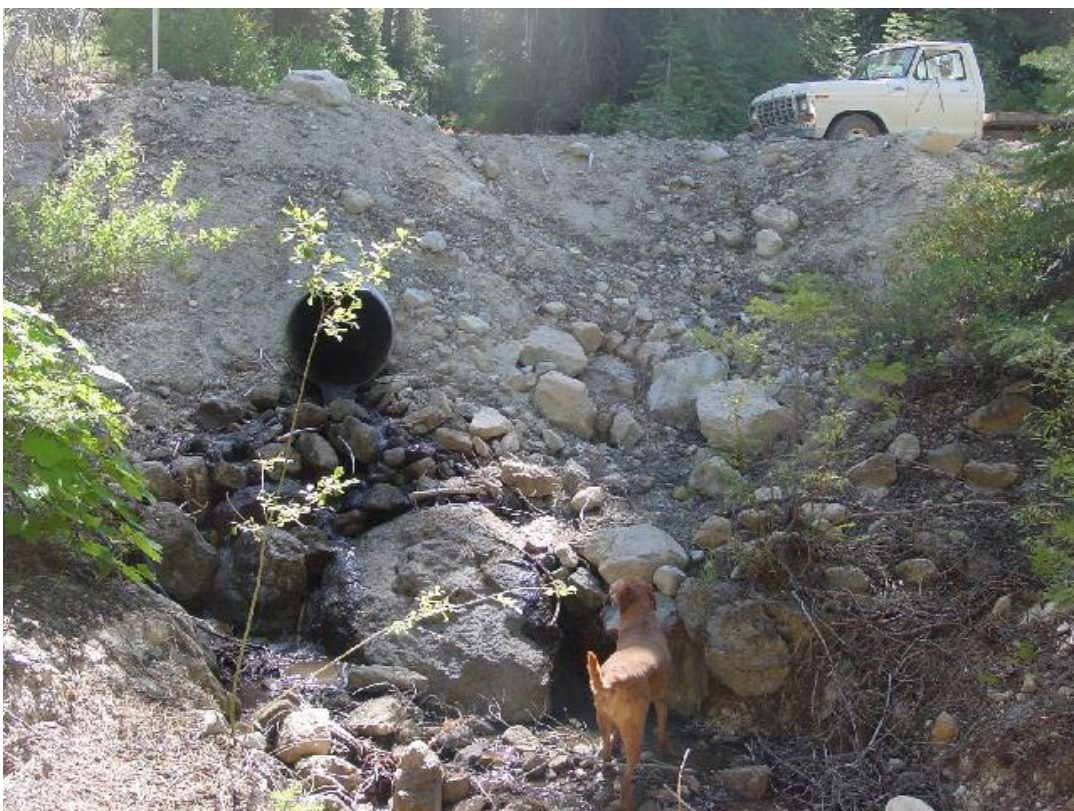
Photo 4.11b

Site 4.11—Below

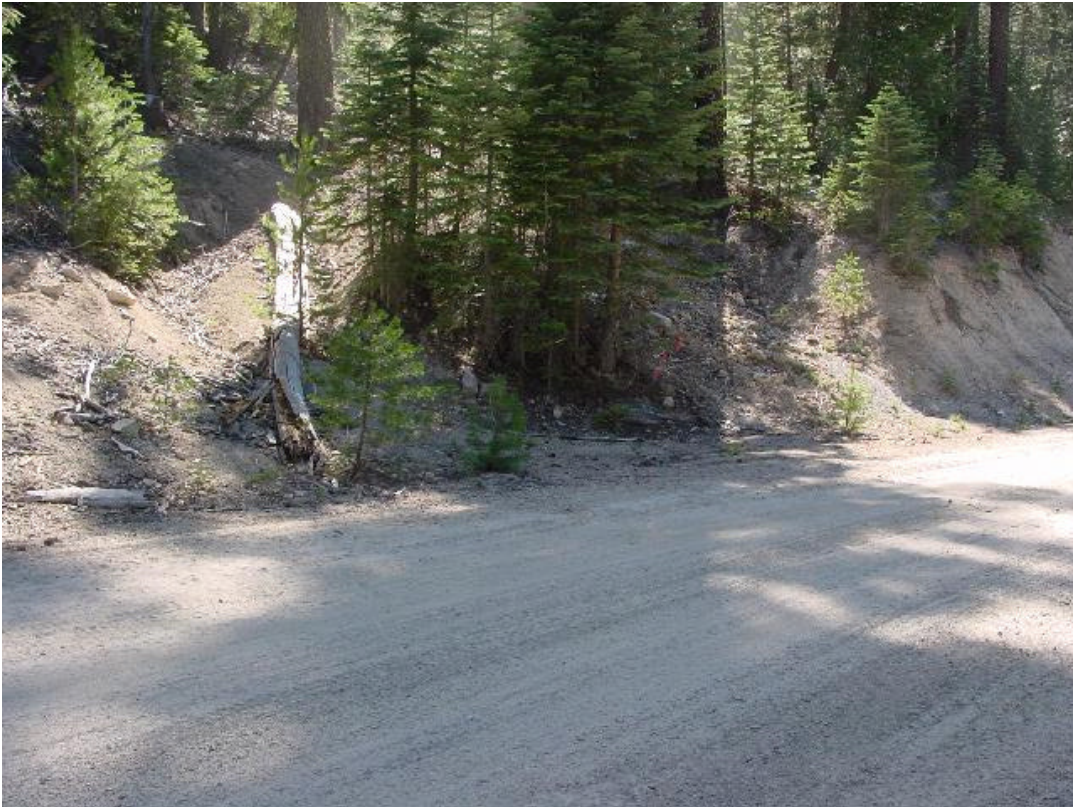
Photo 4.12a

Site 4.12—Above

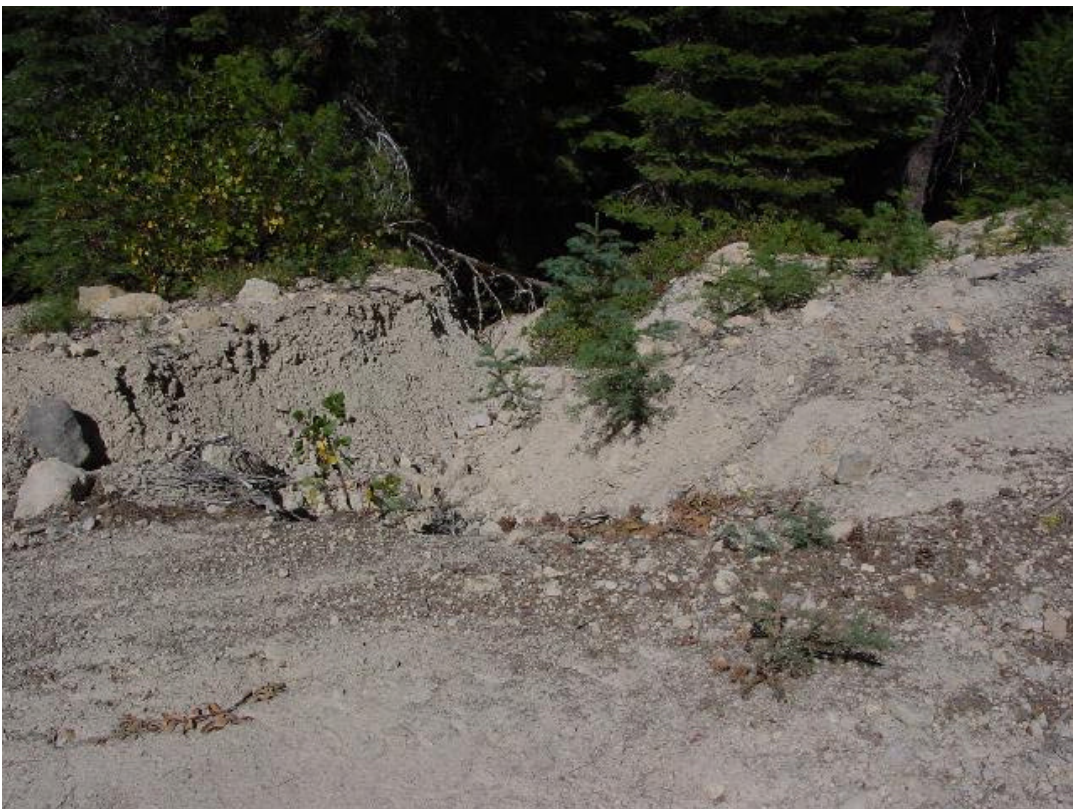
Photo 4.12b

Site 4.12—Below

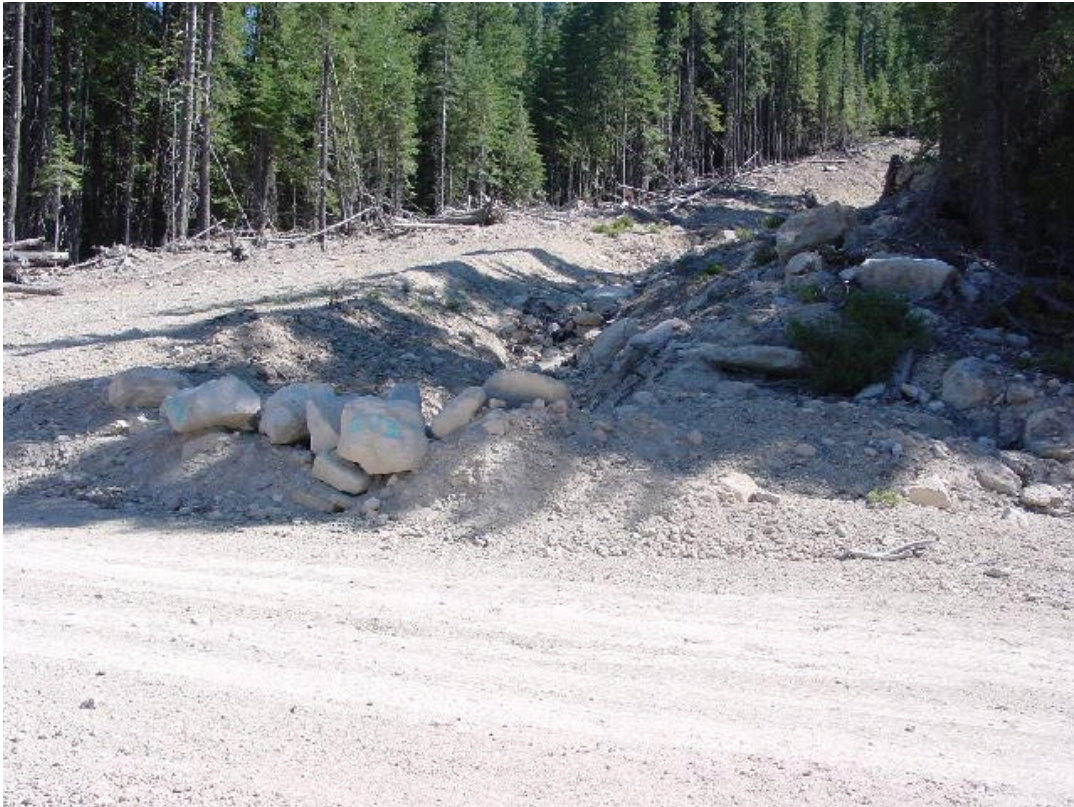
Photo 4.13a

Site 4.13—Above

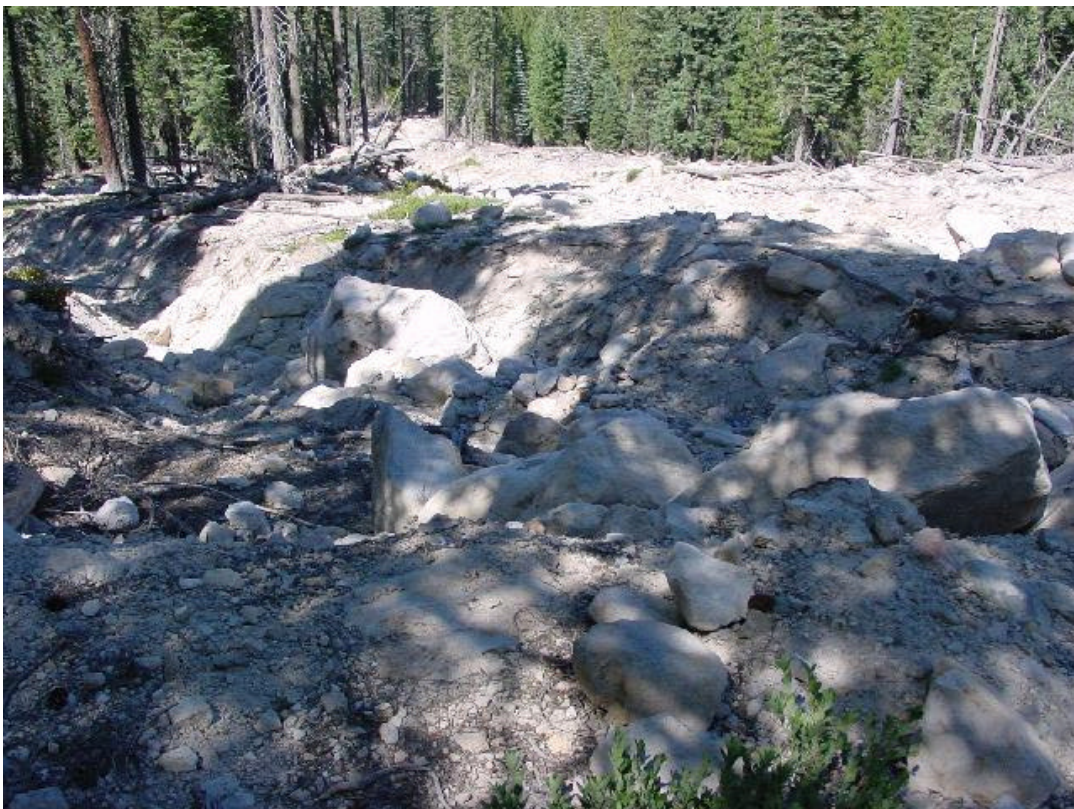
Photo 4.13b

Site 4.13—Below

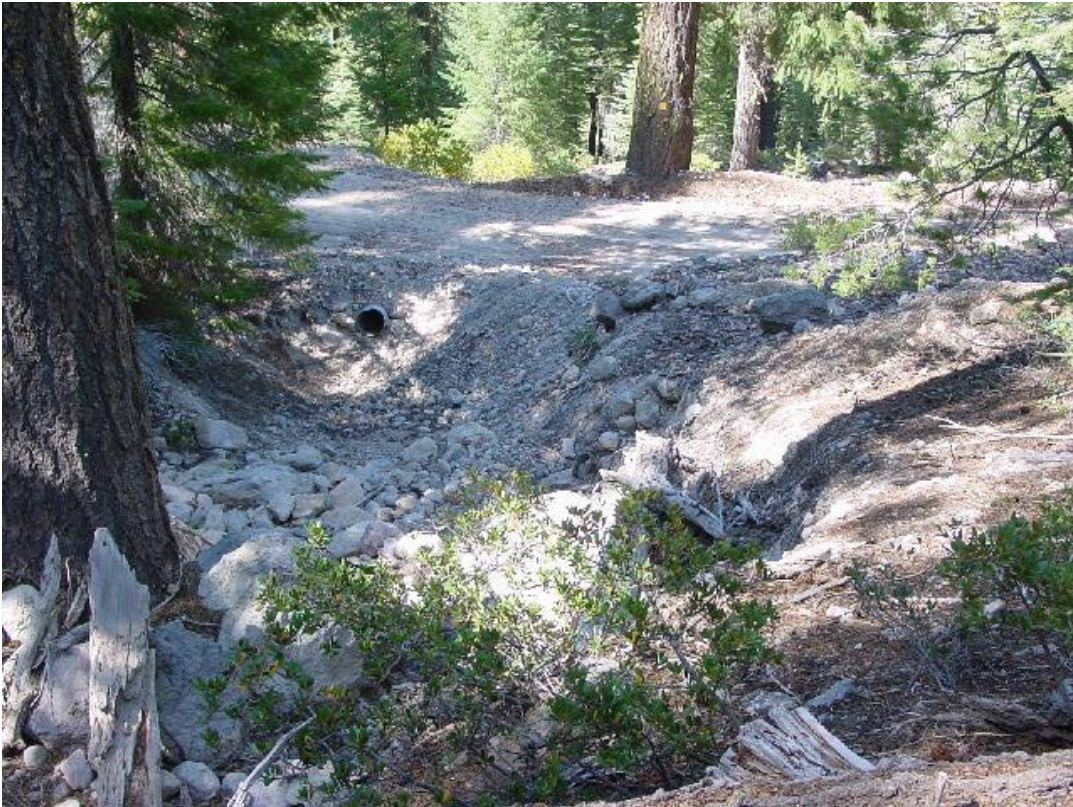
Photo 4.14a

Site 4.14—Above

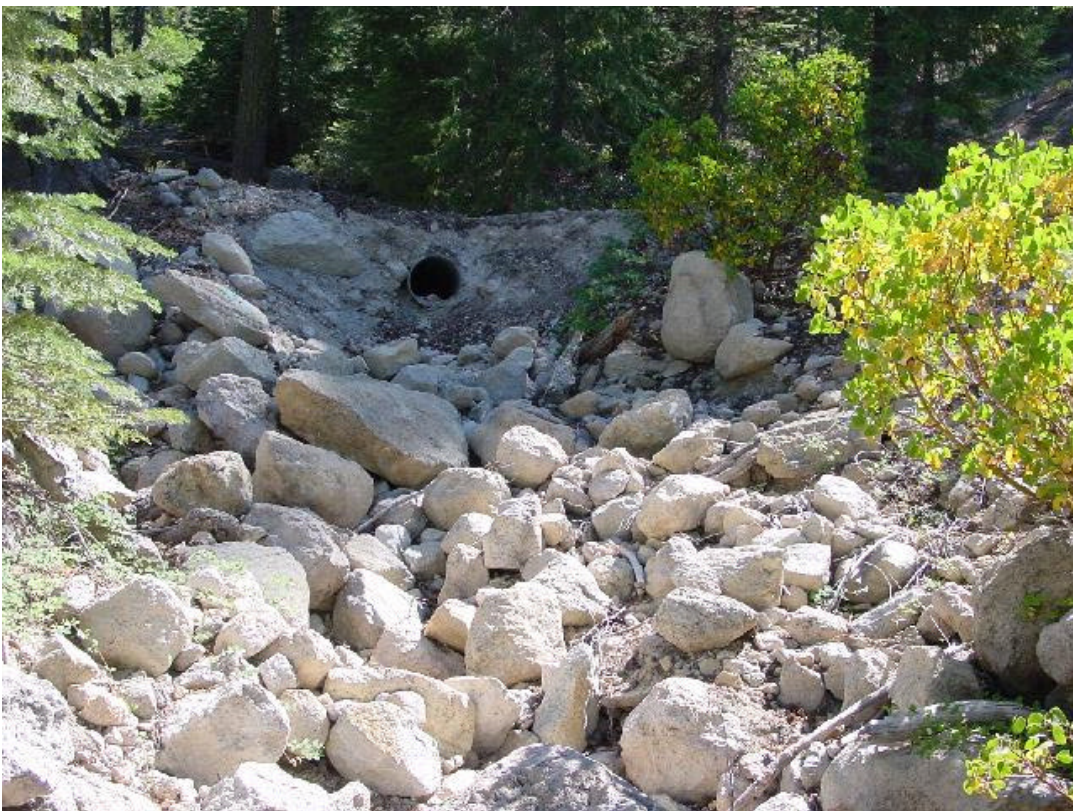
Photo 4.14b

Site 4.14—Below

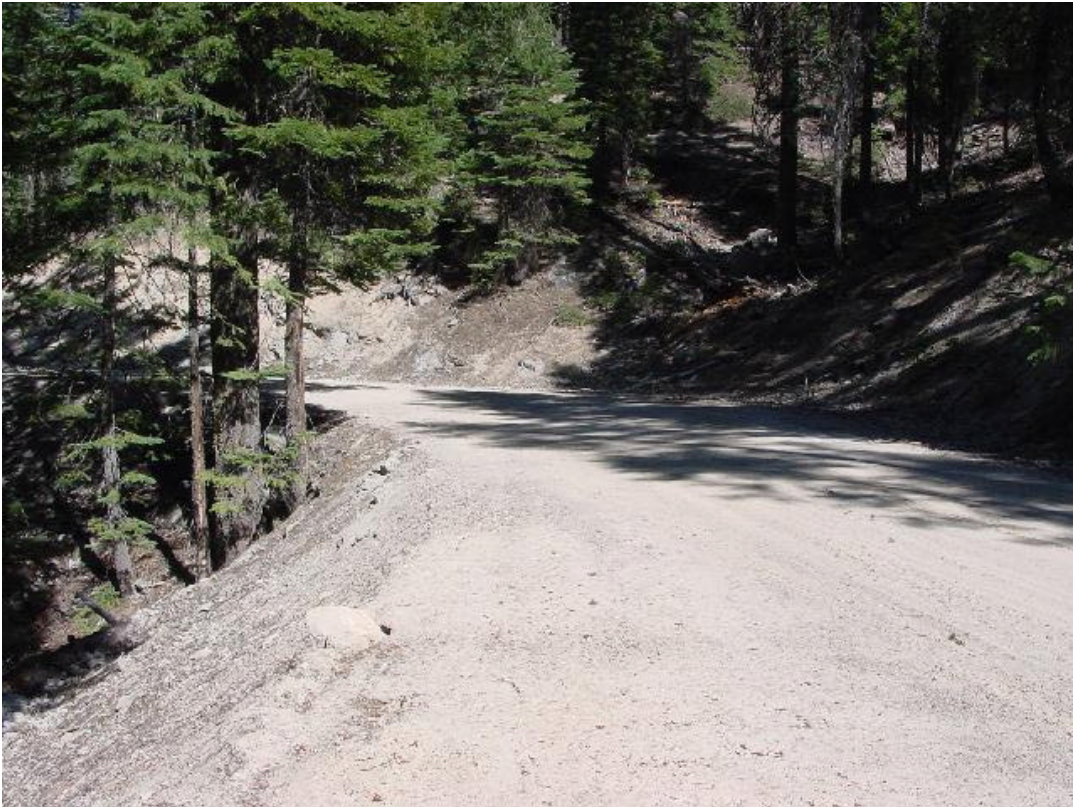
Photo 4.15a

Site 4.15—General View

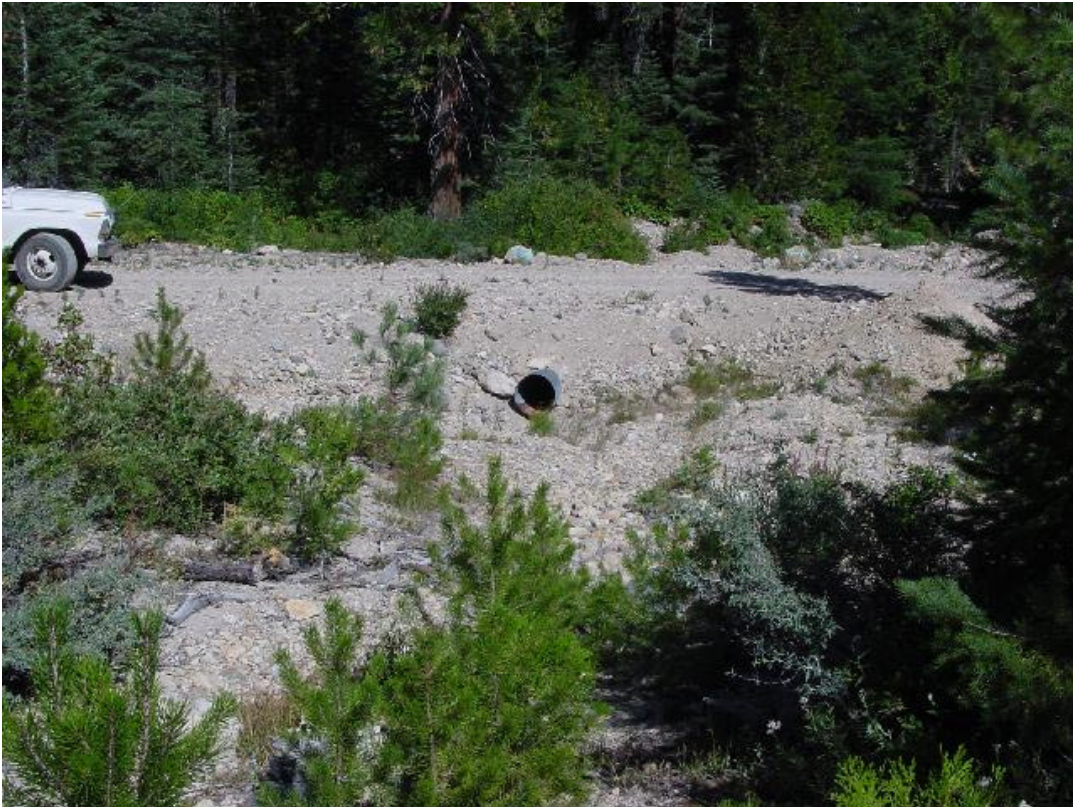
Photo 4.18a

Site 4.18—Above

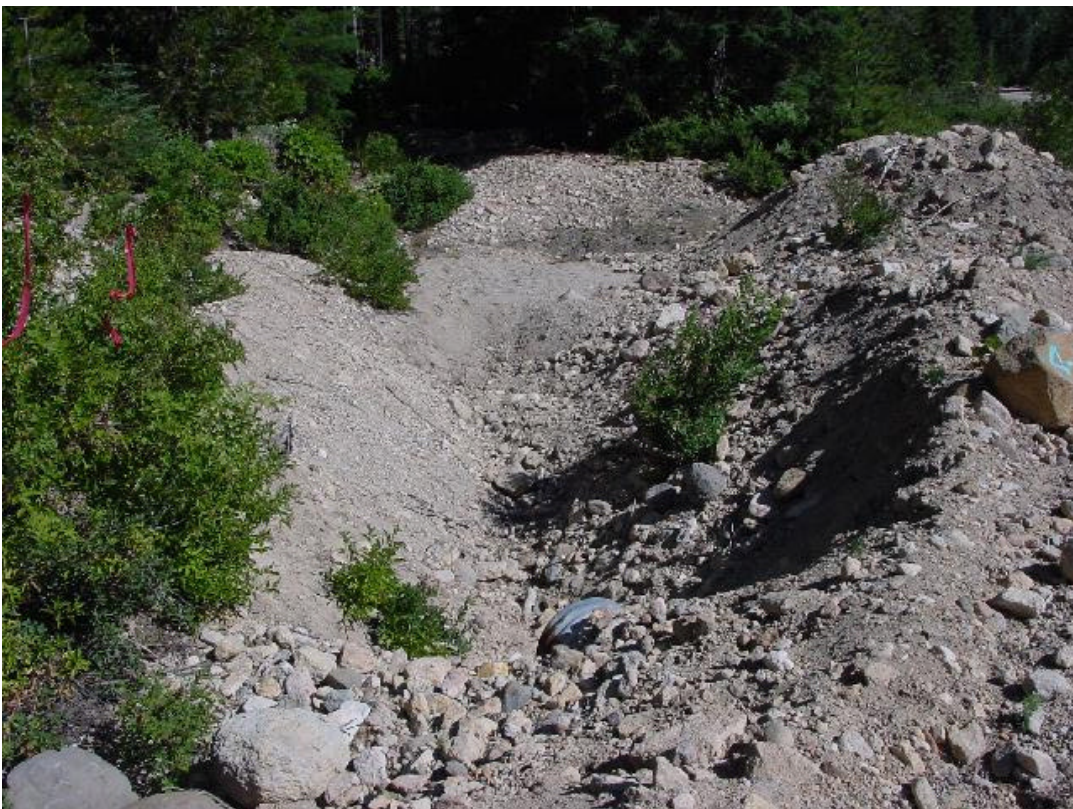
Photo 4.18b

Site 4.18—Below

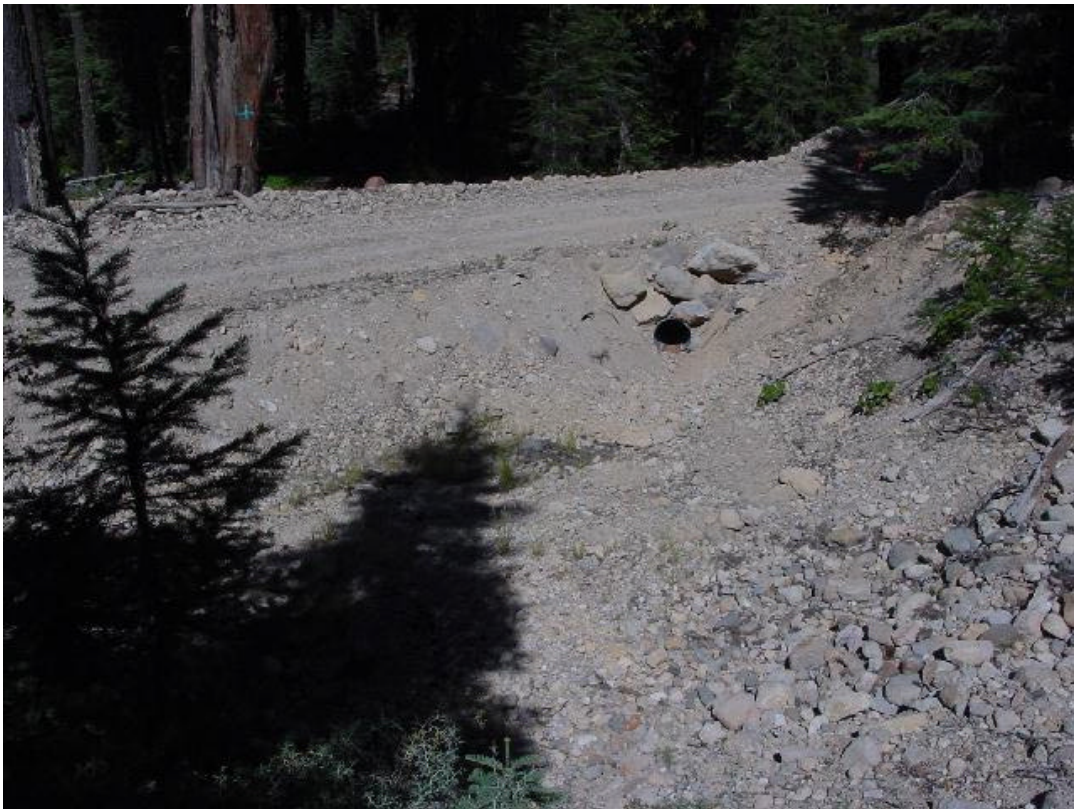
Photo 4.19a

Site 4.19—Above

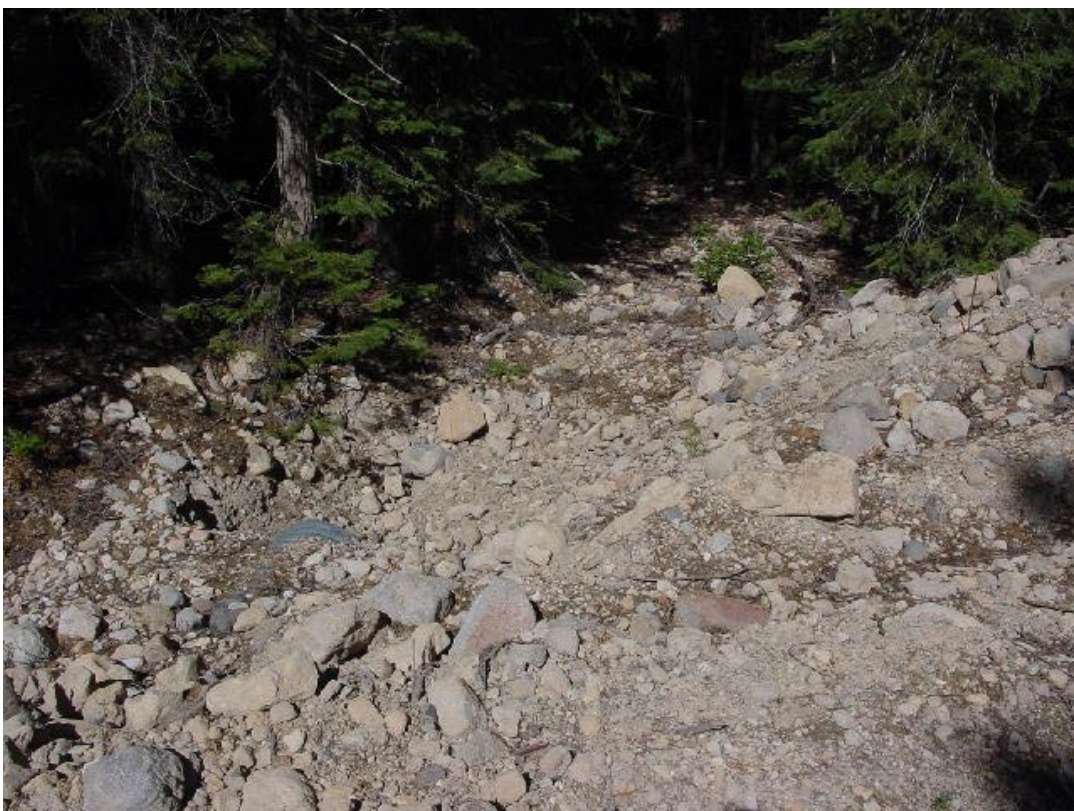
Photo 4.19b

Site 4.19—Below

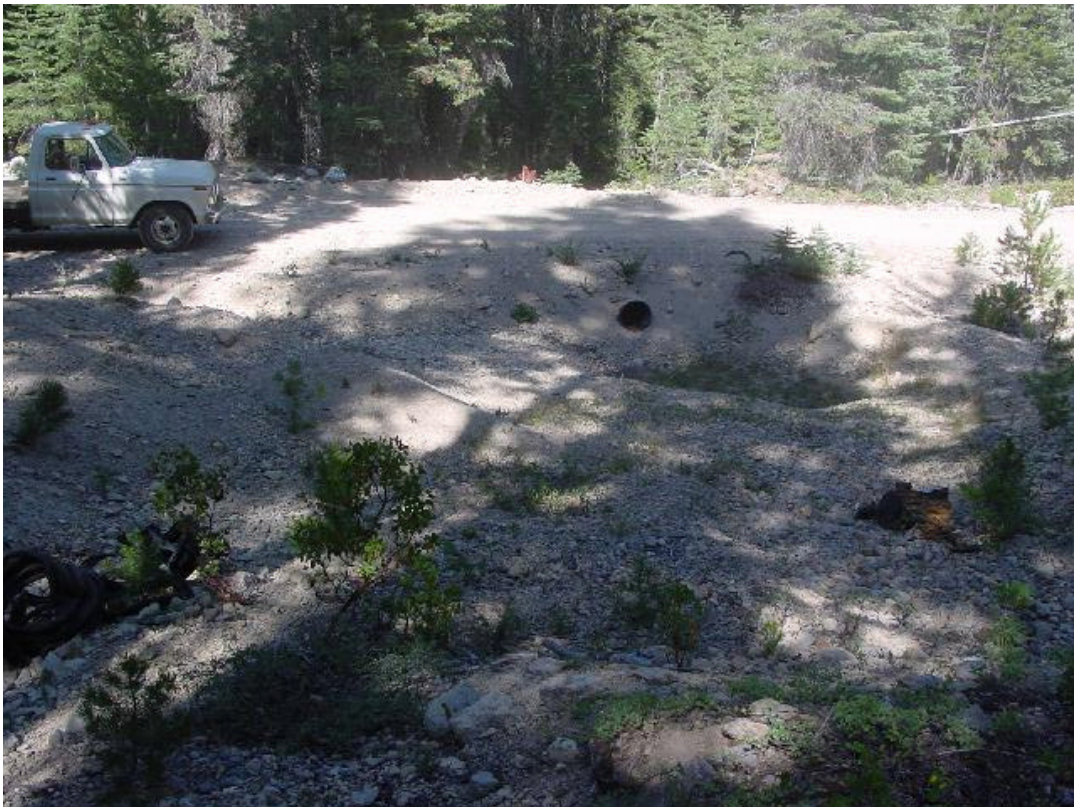
Photo 4.20a

Site 4.20—

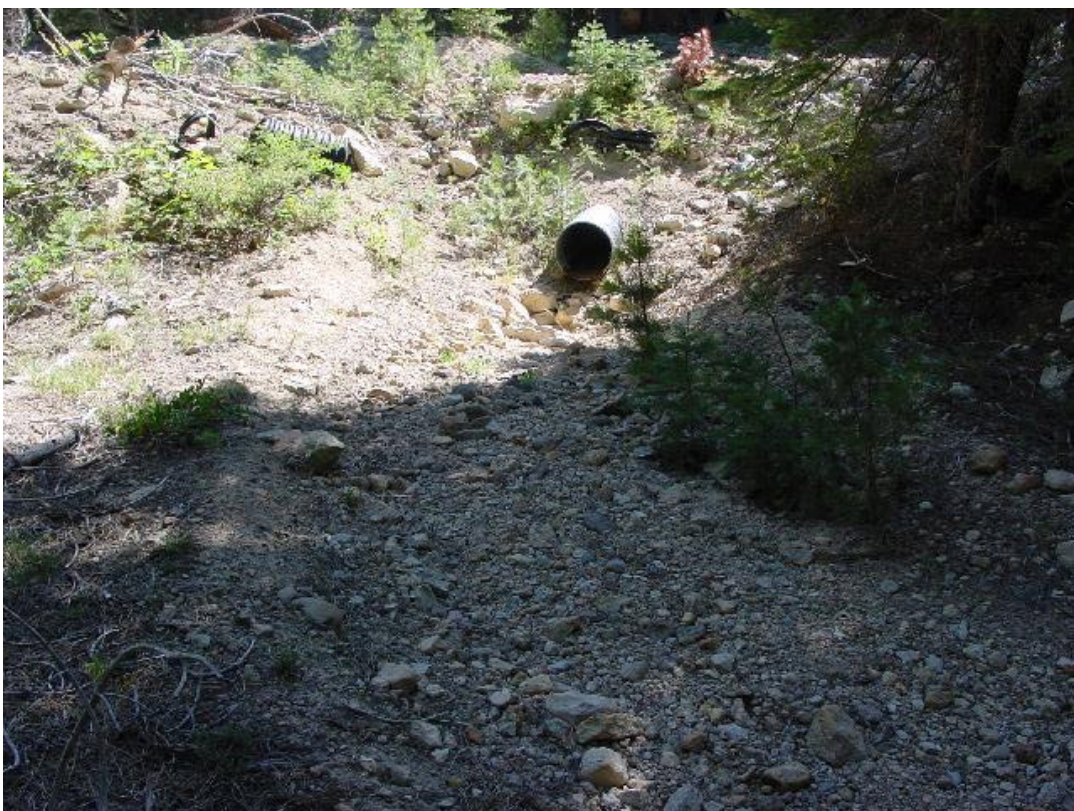
Photo 4.20.b

Site 4.20—Below
